**BUILDING
MATERIALS
AND
STRUCTURES**
REPORT BMS90

Structural Properties of
"PHC" Prefabricated
Wood-Frame Constructions
for Walls, Floors, and Roofs
Sponsored by
the PHC Housing Coporation

NATIONAL
BUREAU OF STANDARDS

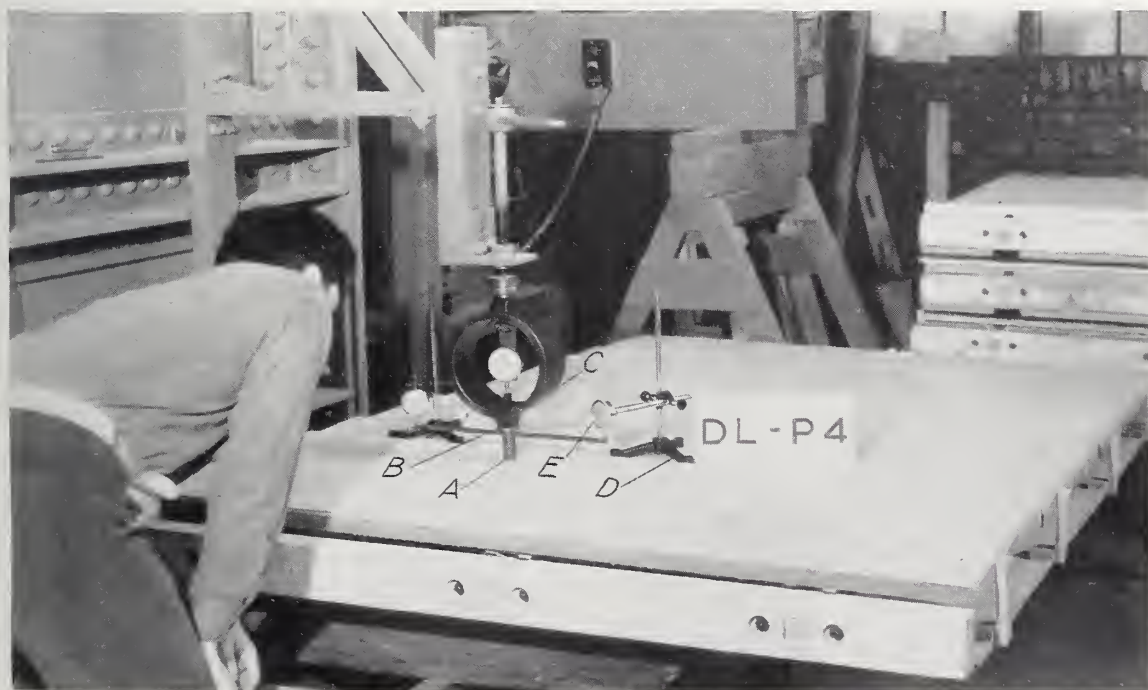
FIGURE 1.—Apparatus for concentrated-load test.

The load was applied to the steel disk, *A*, to which the cross bar, *B*, was rigidly attached. The load was measured by means of the dynamometer, *C*. Two stands, *D*, rested on the

A, steel disk; *B*, cross bar, *C*, dynamometer; *D*, stand, *E*, dial micrometer.

face of the specimen, each supporting a dial micrometer, *E*, the spindle of which was in contact with the cross bar 8 in. from the center of the disk. The micrometers were graduated to 0.001 in., and readings were recorded to the nearest division. The initial reading (average of the micrometer readings) was observed under the initial load, which included the weight of the disk and the dynamometer. A load was applied to the disk, and the average of these micrometer readings minus the initial reading was taken as the depth of the indentation under load.

The indentation under concentrated load and the set after the load was removed were measured, not the set only as described in BMS2. The apparatus is shown in figure 1.

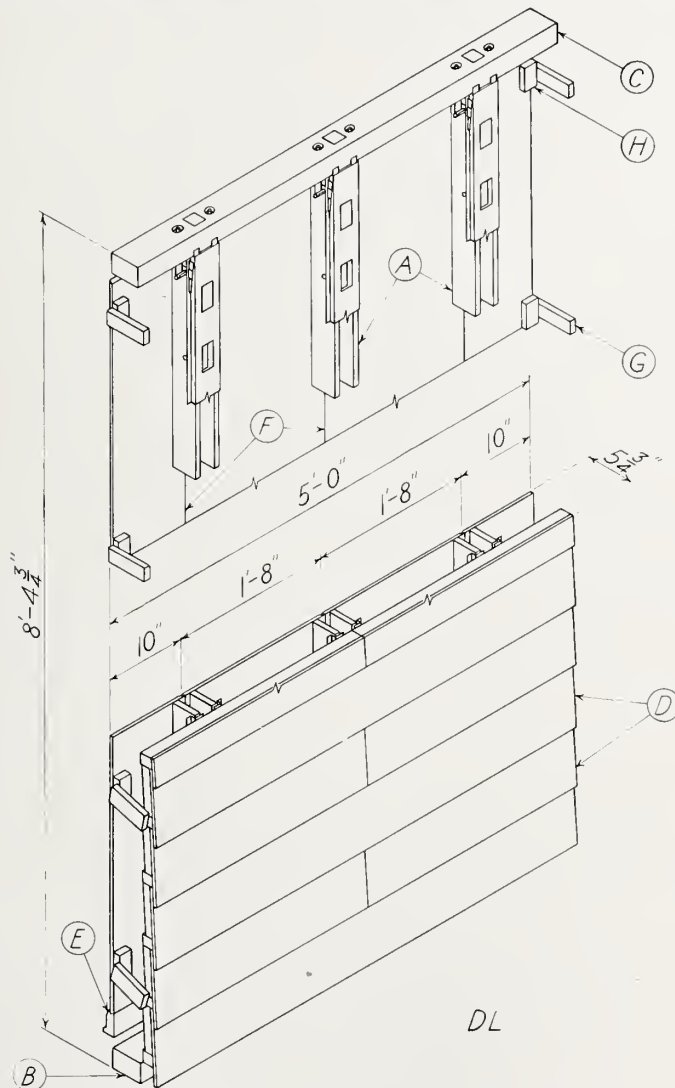
FIGURE 7.—Four-foot wall specimen *DL*.

The 4-ft wall specimens, shown in figure 7, were 8 ft $4\frac{3}{4}$ in. high, 5 ft 0 in. wide, and $5\frac{3}{4}$ in. thick. Each specimen consisted of a wood frame to which the faces were attached. The frame was three prefabricated wood studs, *A*, attached to a wood floor plate, *B*, and top plate, *C*, by hook bolts. The outside face was 19

A. stud; *B.* floor plate; *C.* top plate; *D.* siding; *E.* base-molding; *F.* wallboard panels; *G.* spacers; *H.* blocks.

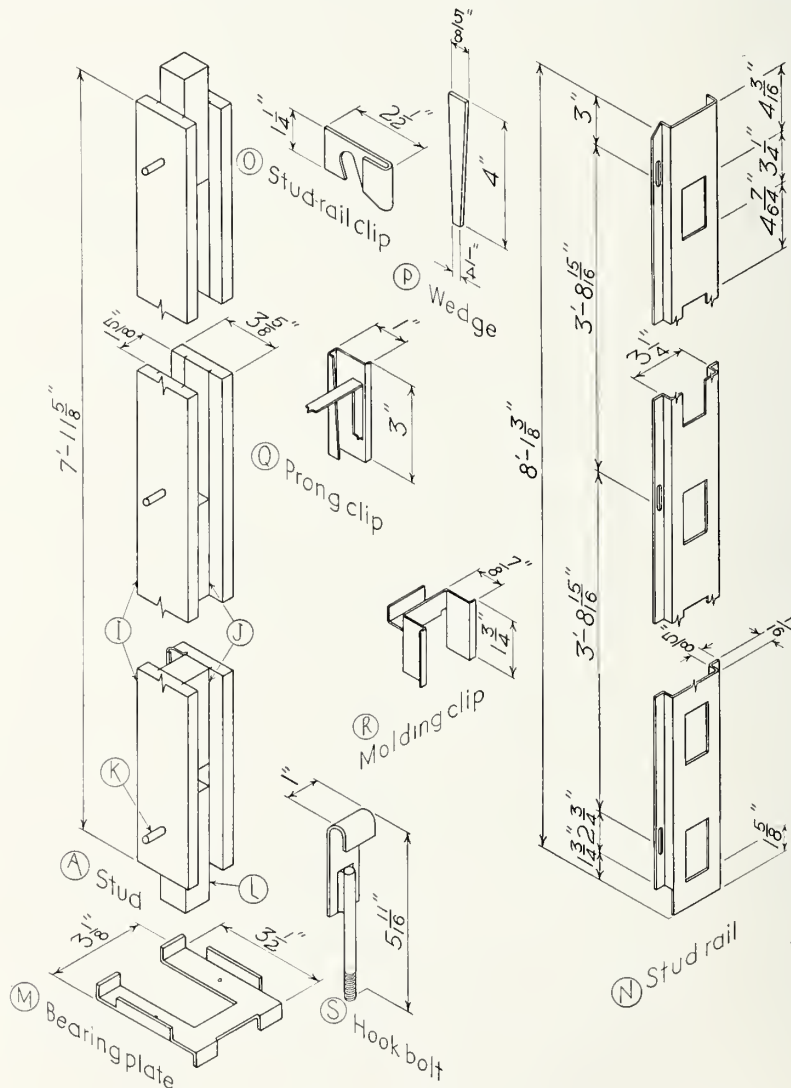
FIGURE 8.—Details of the stud.

6 in. long. The blocks were centered $9\frac{3}{8}$ in., 2 ft $2\frac{5}{8}$ in., 3 ft $7\frac{7}{8}$ in., 5 ft $1\frac{1}{8}$ in., and 6 ft $10\frac{7}{8}$ in. from the lower end of the stud. Each block was fastened to each board by two 8d casing nails. Seven holes, $\frac{1}{16}$ -in. diam, extended through the boards at midwidth. The distances of the holes from the lower end of the studs were $2\frac{7}{8}$ in., 1 ft $1\frac{5}{16}$ in., 2 ft $6\frac{1}{2}$ in., 3 ft $11\frac{13}{16}$ in., 5 ft $5\frac{1}{8}$ in., 6 ft $10\frac{3}{16}$ in., and 7 ft $8\frac{3}{4}$ in. The holes were for pins to attach the stud rails. There were three steel pins, *K*, $\frac{1}{16}$ -in. diam, $5\frac{1}{2}$ in. long, one through each end hole and one through the hole at midlength. Each end pin fastened a southern-pine tenon, *L*, $1\frac{5}{8}$ by $1\frac{1}{8}$ in.

A, stud; *I*, boards; *J*, blocks; *K*, pin; *L*, tenon; *M*, bearing plate; *N*, stud rail; *O*, stud-rail clip; *P*, wedge; *Q*, prong clip; *R*, molding clip; *S*, hook bolt.

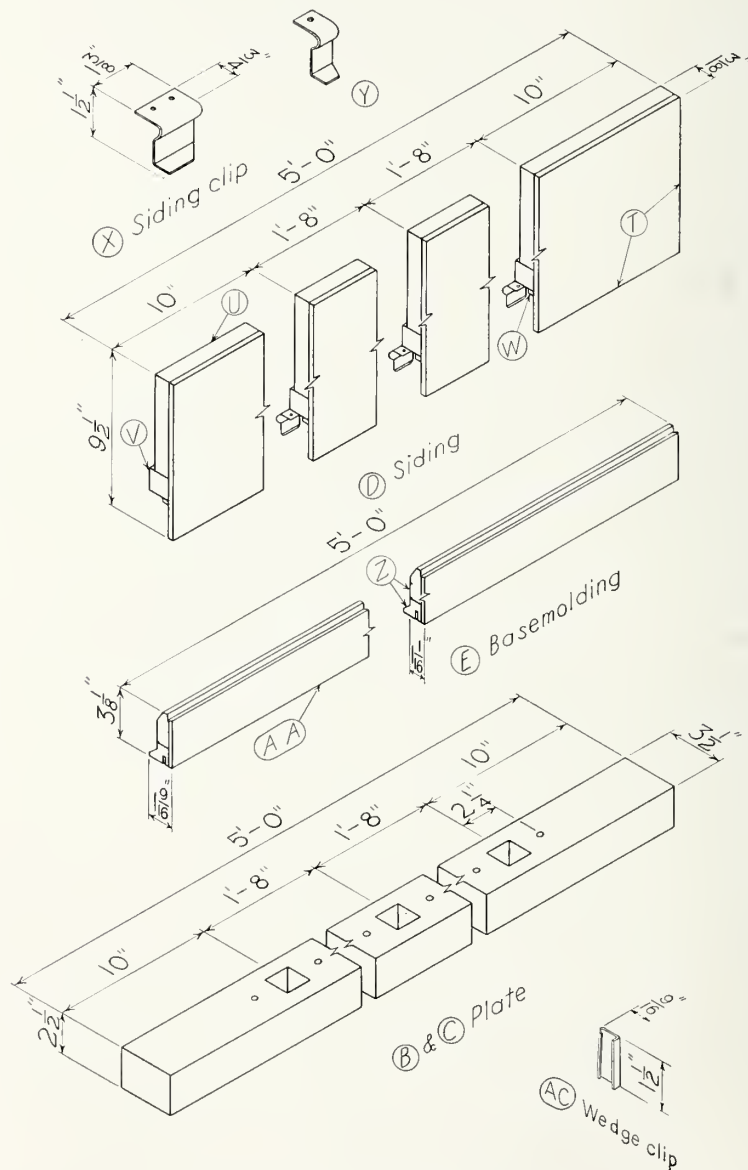
FIGURE 9.—Details of wall DL.

B and *C*, plate; *D*, siding; *T*, plywood; *U*, insulating board; *V*, clip rail; *W*, rubber strip; *E*, basemolding; *Z*, molded strips; *A.A.*, plywood; *X* and *Y*, siding clips; *AC*, wedge clip.

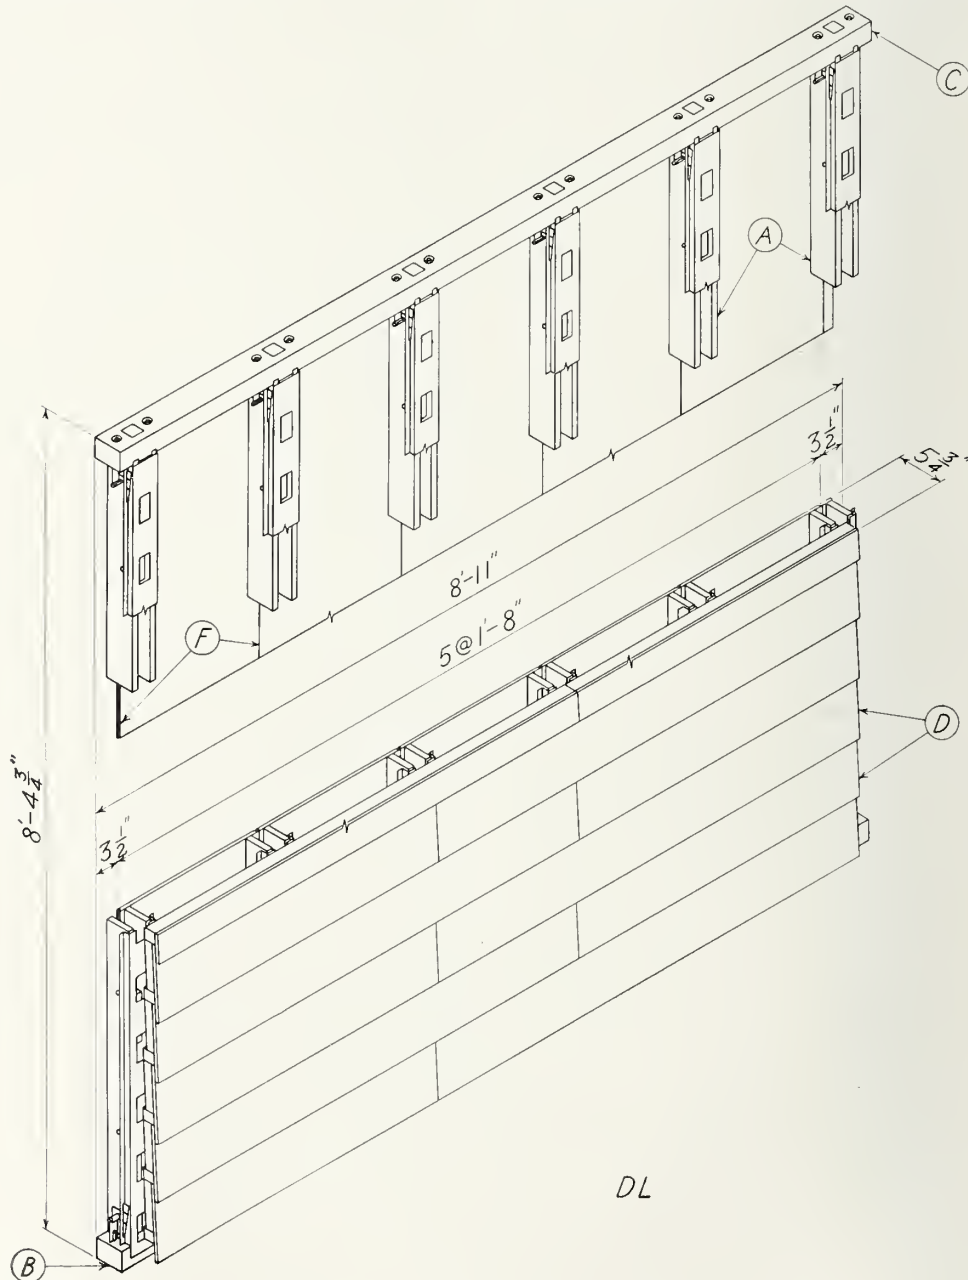
FIGURE 10.—Eight-foot wall specimen *DL*.

A, stud; B, floor plate; C, top plate; D, siding; F, wallboard panels.

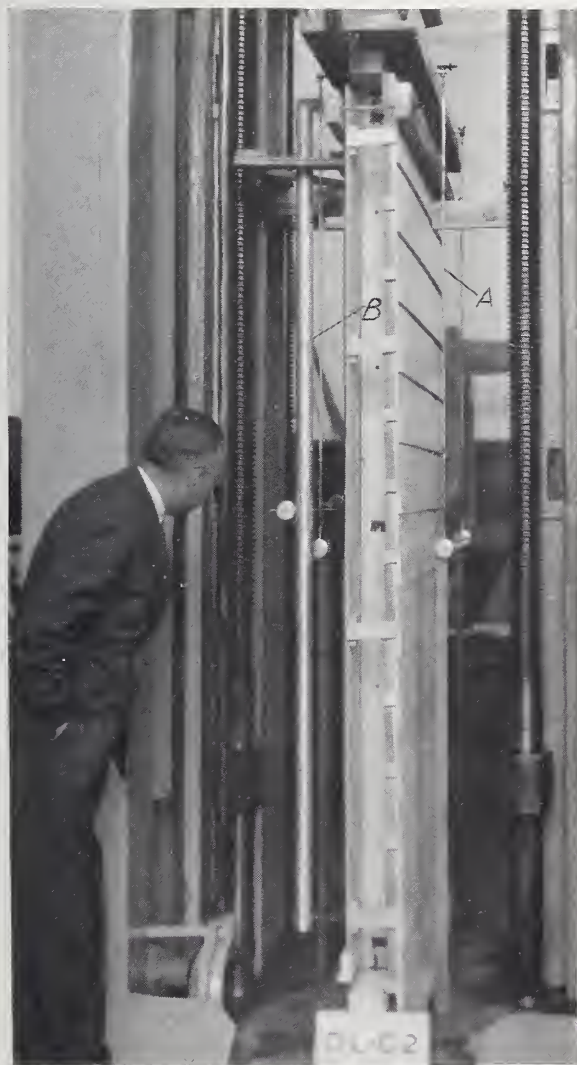
FIGURE 11.—Wall specimen *DL-C2* under compressive load.

A, compressometer; B, deflectometer.

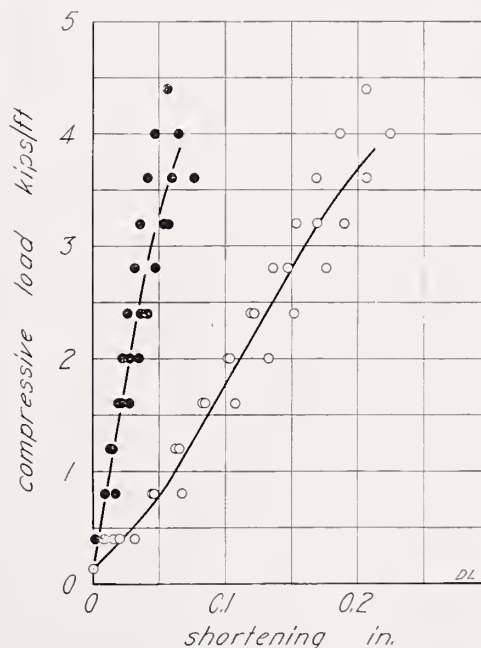
FIGURE 12.—Compressive load on wall *DL*.

Load-shortening (open circles) and load-set (solid circles) results for specimens *DL-C1*, *C2*, and *C3*. The load was applied 1.21 in. (one-third the thickness of the frame) from the inside face. The loads are in kips per foot of actual width of specimen.

The results for specimens *DL-C1*, *C2*, and *C3* are given in table 9 and in figures 12 and 13.

The compressive loads were applied 1.21 in. (one-third the thickness of the frame) from the inside face of the studs. The shortenings and sets (fig. 12) are for a height of 8 ft 4 $\frac{3}{4}$ in. The

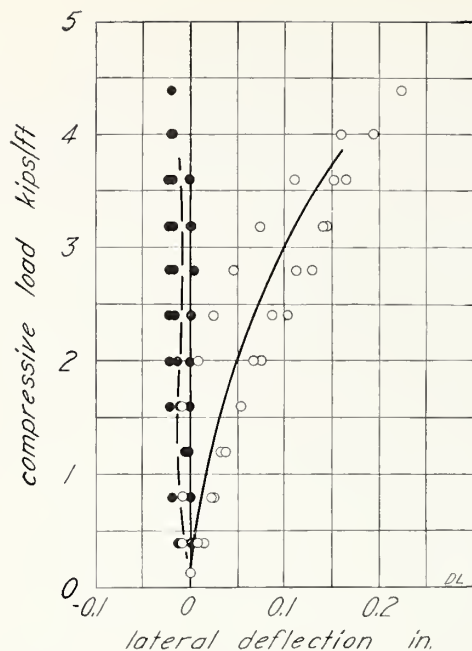
FIGURE 13.—Compressive load on wall DL.

Load-lateral deflection (open circles) and load-lateral set (solid circles) results for specimens DL-C1, C2, and C3. The load was applied 1.21 in. (one-third the thickness of the frame) from the inside face. The loads are in kips per foot of actual width of specimen. The deflections and sets are for a gage length of 7 ft 6 in., the gage length of the deflectionometers.

Under the maximum load, the greatest crushing was $\frac{1}{8}$ in. No other effects were observed except that one board of an outer stud in specimen C3 cracked longitudinally at the upper end.

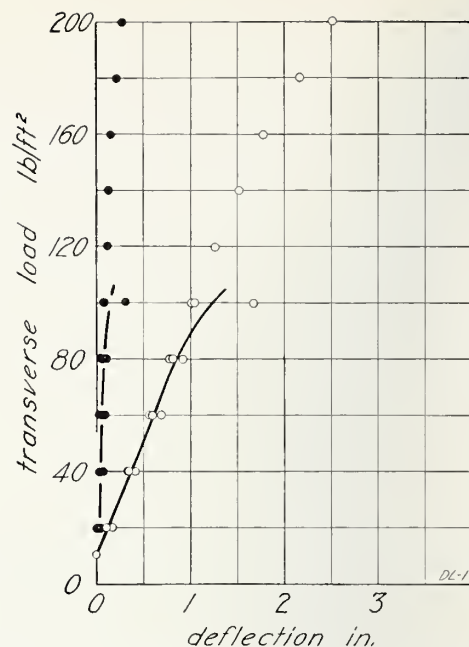
FIGURE 14.—Transverse load on wall DL, load applied to inside face.

Load-deflection (open circles) and load-set (solid circles) results for specimens DL-T1, T2, and T3 on the span 7 ft 6 in.

side face (wallboard) of specimens DL-T1, T2, and T3. For each specimen, as the loads increased the studs deflected and the exposed

edges of the siding between the loading rollers separated outwardly from the adjacent siding. Under a load of 60 lb/ft² on specimen *T1*, the separation was noticeable, and under 70 lb/ft² measured 3/8 in. in some places. The separation of the siding in this specimen was typical of that in specimens *T2* and *T3*. Under a load of 123 lb/ft² on *T1*, an outer stud cracked at a knot, and under the maximum load split longitudinally through the hole at midlength.

One piece of siding in specimen *T2* separated from the adjacent piece under a load of 40 lb/ft² because, when assembled, the siding clips had not engaged the stud rails. Under a load of 95 lb/ft², an outer stud cracked at three knots. Under the maximum load, this stud ruptured and the middle stud cracked.

In specimen *T3* an outer stud cracked at a load of 212 lb/ft². Under the maximum load, all the studs ruptured.

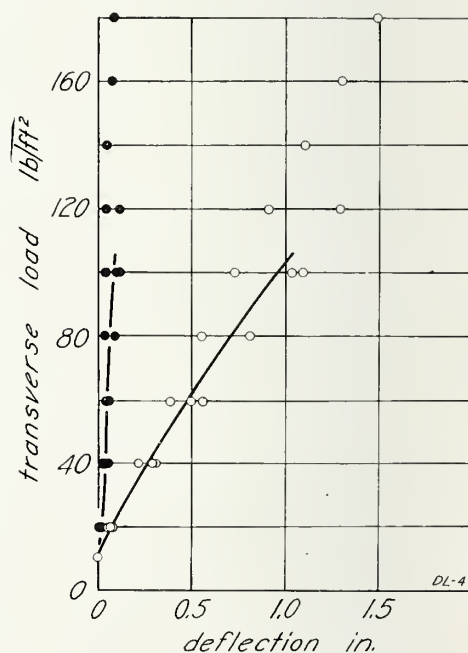
FIGURE 15.—Transverse load on wall DL, load applied to outside face.

Load-deflection (open circles) and load-set (solid circles) results for specimens DL-T4, T5, and T6 on the span 7 ft 6 in.

The transverse loads were applied to the outside face (siding) of specimens *DL-T4*, *T5*, and *T6*. In specimen *T4* one outer stud ruptured at midspan under a load of 70 lb/ft². At 80 lb/ft² a half-width wallboard panel separated from an outer stud at midspan. Under the maximum load the middle stud also ruptured. In specimen *T5* under a load of 129 lb/ft², one outer stud ruptured at a knot near midspan. At 162 lb/ft² the ruptured stud displaced a half-width wallboard panel. Under the maximum load, the middle stud ruptured near the loading rollers. In specimen *T6* one outer stud cracked under a loading roller at a load of 152 lb/ft²; and under 243 lb/ft² the other outer stud cracked at midspan. Under the maximum load, all the studs ruptured and there was a separation of the wallboard along one outer stud.

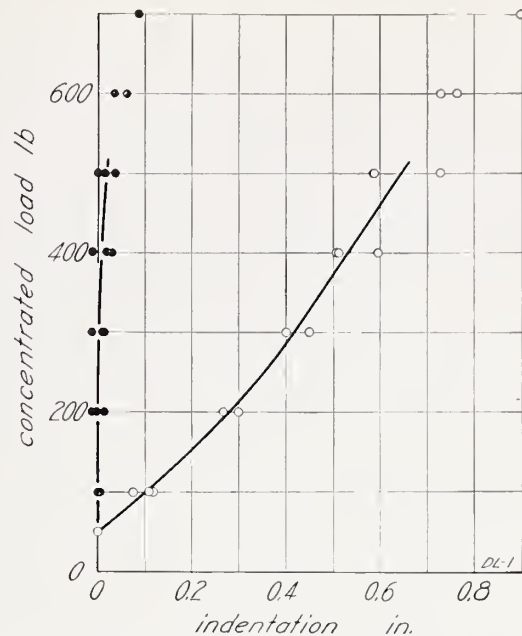
FIGURE 16.—Concentrated load on wall *DL*, load applied to inside face.

Load-indentation (open circles) and load-set (solid circles) results for specimens *DL-P1*, *P2*, and *P3*.

The concentrated load was applied to the inside face (wallboard) of specimens *P1*, *P2*,

and *P3* midway between two studs and 20 in. from one end of the specimen. Under the maximum load on each specimen the disk punched through the wallboard.

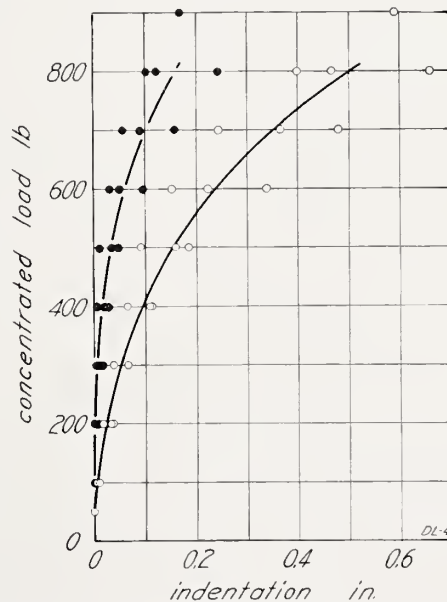
FIGURE 17.—Concentrated load on wall *DL*, load applied to outside face.

Load-indentation (open circles) and load-set (solid circles) results for specimens *DL-P4*, *P5*, and *P6*.

The concentrated load was applied to the outside face (siding) of specimens *P4*, *P5*, and *P6* midway between two studs and 5½ in. from the exposed edge of a piece of siding. Under a load of 800 lb. on specimens *P4* and *P6*, the siding cracked adjacent to the disk. Under the maximum load on each specimen, the disk punched through the siding.

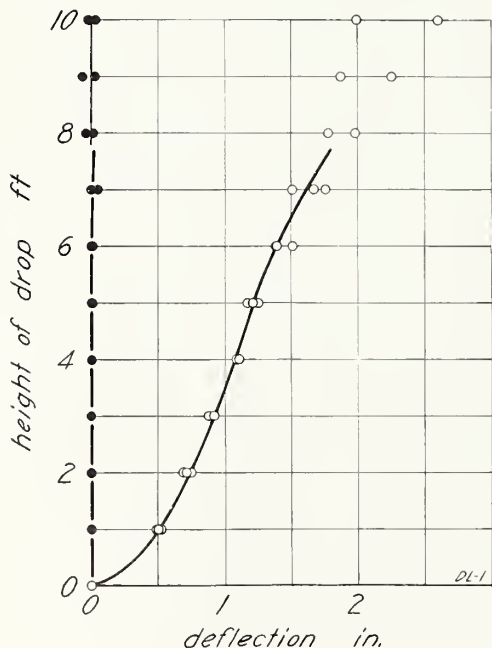
FIGURE 18.—Impact load on wall *DL*, load applied to inside face.

Height of drop-deflection (open circles) and height of drop-set (solid circles) results for specimens *DL-11*, *I2*, and *I3* on the span 7 ft 6 in.

The impact loads were applied to the inside face (wallboard) of specimens *DL-11*, *I2*, and *I3*. The sandbag struck the center of the specimen over the middle stud. On specimen *DL-11*, after a drop of 3.5 ft, a half-width wallboard panel was loose. One piece of siding separated from the studs at a drop of 5.0 ft because, when assembled, none of the clips had engaged the stud rails. Additional pieces of siding fell off as the height of drop was increased.

A full-width wallboard panel separated from the studs at a drop of 7.0 ft. After a drop of 9.0 ft the middle stud was cracked where the sandbag struck.

In specimen *I2* after a drop of 6.0 ft the base-molding was loose, and after a drop of 7.0 ft a half-width wallboard panel separated from an outer stud and a piece of siding began to sepa-

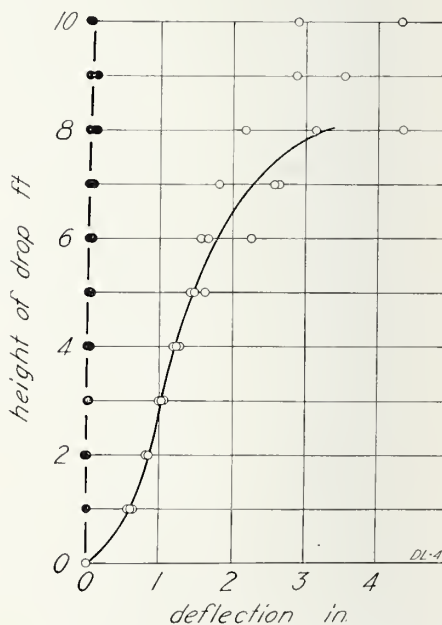
FIGURE 19.—Impact load on wall *DL*, load applied to outside face.

Height of drop-deflection (open circles) and height of drop-set (solid circles) results for specimens *DL-14*, *I5*, and *I6* on the span 7 ft 6 in.

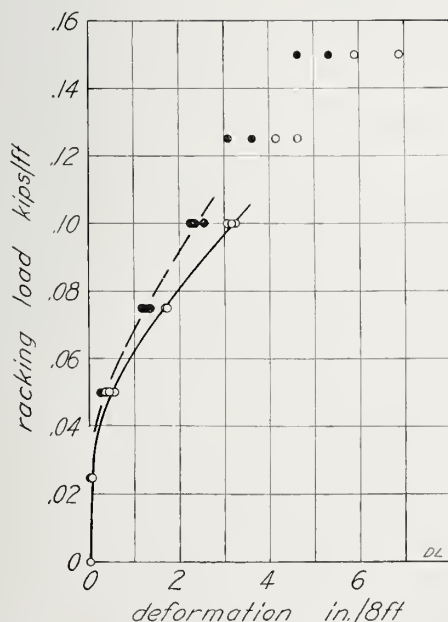
FIGURE 20.—Racking load on wall *DL*.

Load-deformation (open circles) and load-set (solid circles) results for specimens *DL-R1*, *R2*, and *R3*. The loads are in kips per foot of actual width of specimen.

The maximum load on each specimen was taken as the load under which the deformation was 7 in., in a height of 8 ft. Under the maximum load on each specimen, there was increased displacement of adjacent pieces of siding and of the wallboard panels.

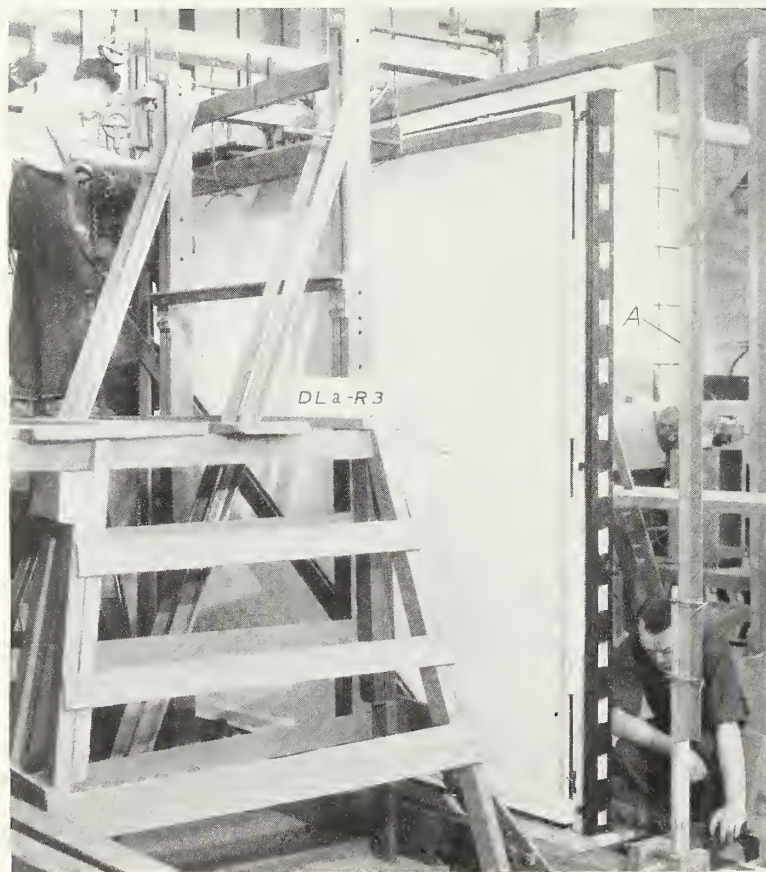
FIGURE 23.—Wall specimen *DLa-R3* under racking load.

A, deformeter.

Under a load of 0.200 kip/ft on specimen *DLa-R1* and of 0.275 kip/ft on specimens *R2* and *R3*, the adjacent wallboard panels were displaced $\frac{1}{2}$ in. vertically and the adjacent pieces of siding were displaced $\frac{1}{16}$ in. horizontally. Under the maximum load on each specimen, the vertical displacement of the wallboard was $1\frac{1}{4}$ in. and the horizontal displacement of the siding was $\frac{3}{8}$ in. In each specimen the lag screws (at midheight) fastening the braces pulled from the corner studs. In specimen *R3* the studs adjacent to the corner studs cracked.

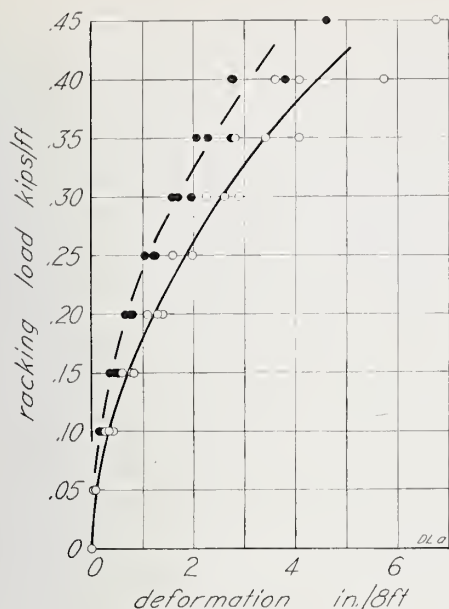
FIGURE 24.—Racking load on wall *DLa*.

Load-deformation (open circles) and load-set (solid circles) results for specimens *DLa*–*R1*, *R2*, and *R3*.

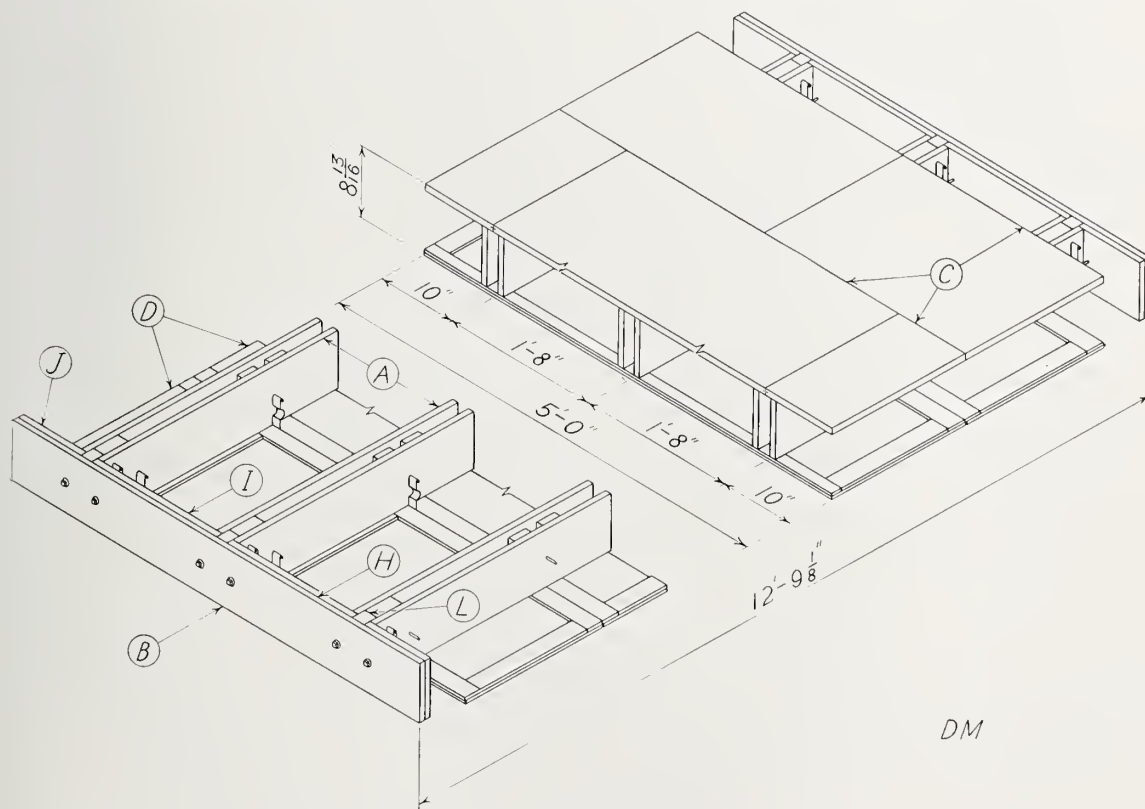
FIGURE 25.—Floor *DM*.

The floor specimens, shown in figure 25, were 12 ft 9 $\frac{1}{8}$ in. long, 5 ft 0 in. wide, and 8 $\frac{13}{16}$ in. deep. Each specimen consisted of a wood frame to which the faces were attached. The

A, joist; *B*, girt; *C*, flooring panel; *D*, ceiling panel; *H*, *I*, *J*, boards; *L*, blocks.

Girts.—The girts, *B* (fig. 25), were prefabricated members, each consisting of five pieces of southern pine, $\frac{25}{32}$ by $7\frac{3}{8}$ in. (nominal 1 by 8 in.); one piece, *H*, 4 ft $11\frac{13}{16}$ in. long; two pieces, *I*, 1 ft $6\frac{3}{8}$ in. long; and two pieces, *J*, $9\frac{3}{32}$ in. long. The pieces *I* and *J* were each fastened to the piece *H*, with a space $1\frac{5}{8}$ in. between adjacent pieces, by five 6d cement-coated casing nails through the piece *H* into the pieces *I* and *J*.

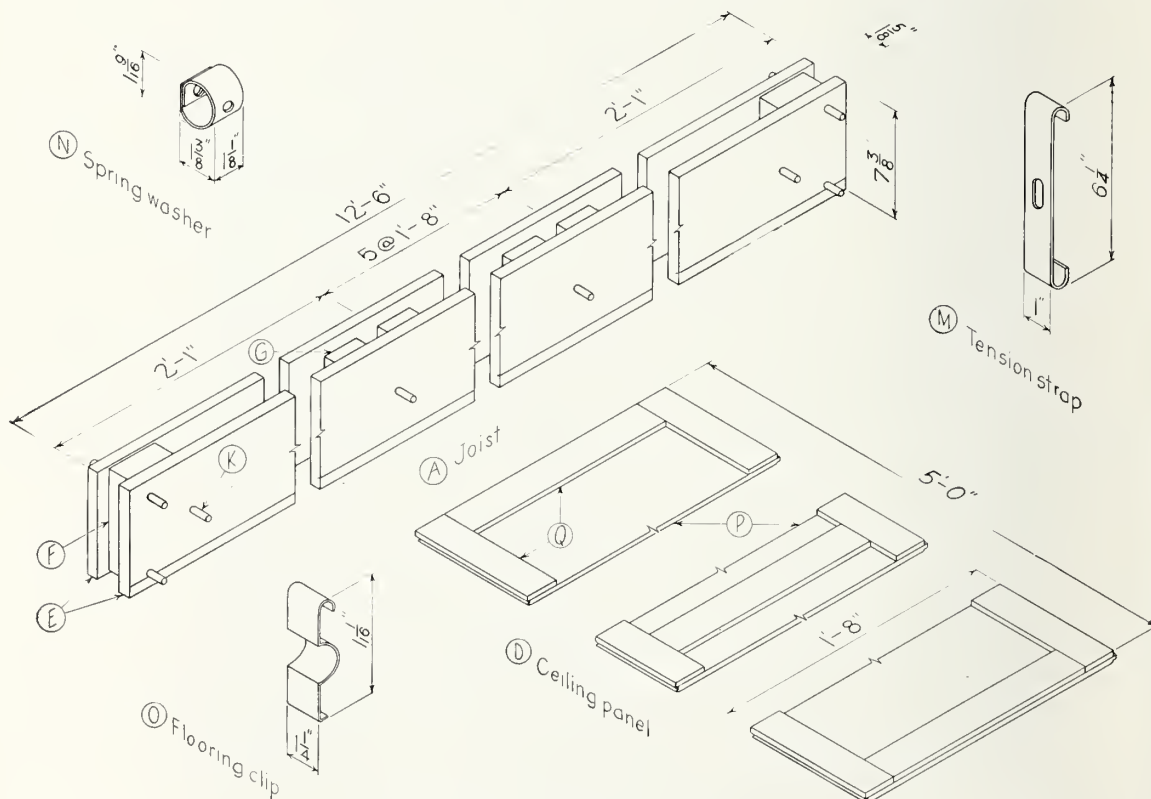
FIGURE 26.—Details of floor DM.

A, joist; *E*, boards; *F*, *G*, blocks; *K*, pin; *D*, ceiling panel; *P*, plywood panel; *Q*, plywood strips; *M*, tension strap; *N*, spring washer; *O*, flooring clip.

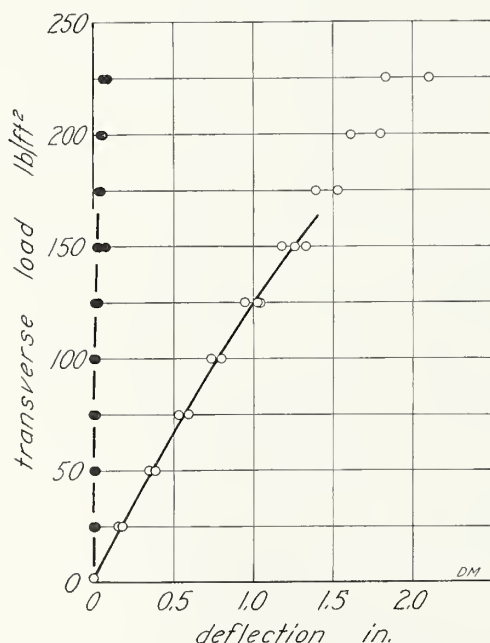
FIGURE 27.—*Transverse load on floor DM.*

Load-deflection (open circles) and load-set (solid circles) results for specimens *DM-T1*, *T2*, and *T3* on the span 12 ft 0 in.

men *T1* opened about ¼ in. under a load of 225 lb/ft² and one board in an outer joist ruptured under a loading roller. Under the maximum load all the joists ruptured and one flooring clip pulled through a ceiling panel.

Under a load of 110 lb/ft² on specimen *T2*, a board in one outer joist ruptured under a loading roller. At a load of 150 lb/ft², the transverse joints in the ceiling were open about ¼ in. The other outer joist ruptured near midspan under a load of 153 lb/ft². Under the maximum load, the middle joist ruptured under a loading roller.

Under a load of 120 lb/ft² on specimen *T3*, one board in an outer joist cracked at a knot outside a loading roller, and under a load of 130 lb/ft² the joist ruptured. Under the maximum load, the middle joist buckled laterally.

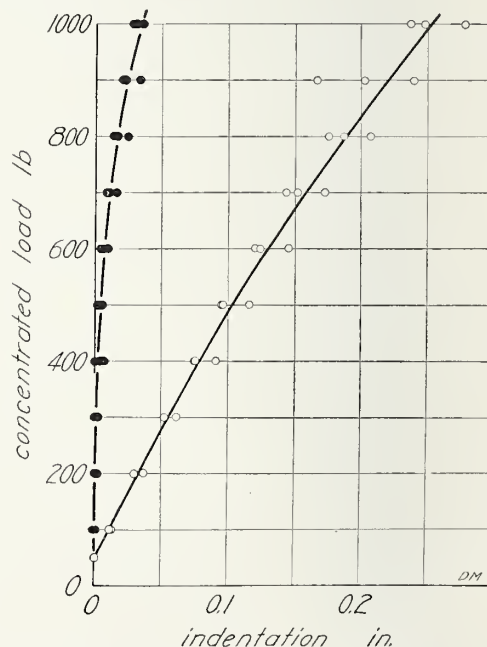
FIGURE 28.—*Concentrated load on floor DM.*

Load-indentation (open circles) and load-set (solid circles) results for specimens *DM-P1*, *P2*, and *P3*.

After the concentrated load had been applied, the set in specimen *DM-P1* was 0.031 in.; in *P2*, 0.037 in.; and in *P3*, 0.028 in. No other effects were observed.

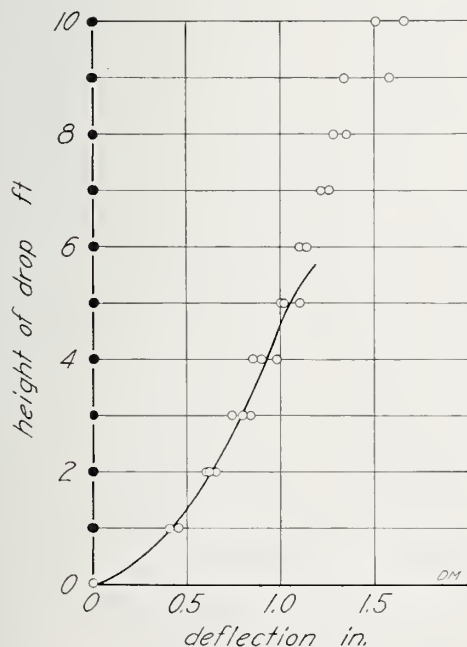
FIGURE 30.—Impact load on floor *DM*.

Height of drop-deflection (open circles) and height of drop-set (solid circles) results for specimens *DM-11*, *I2*, and *I3*, on the span 12 ft 0 in.

After the 10-ft drop on each specimen, the joists were undamaged. Most of the ceiling and flooring panels were loose.

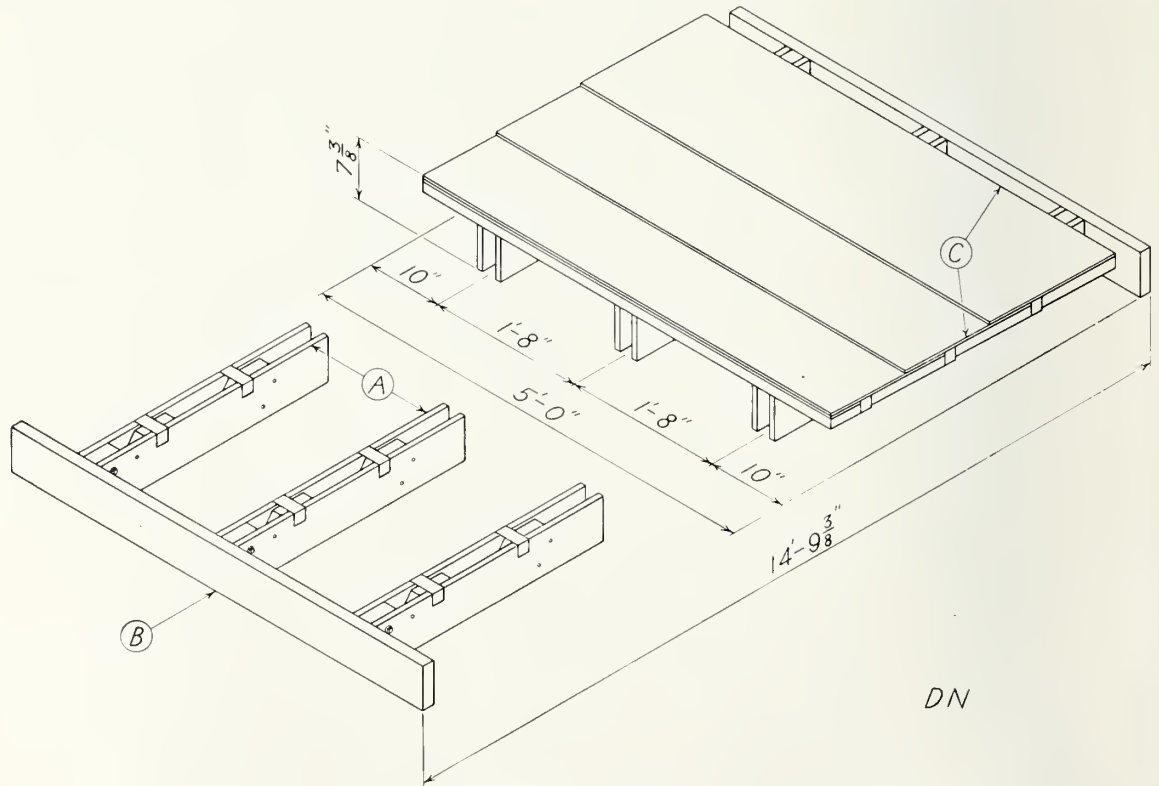
FIGURE 31.—Roof DN.

A, rafter; *B*, header; *C*, roofing.

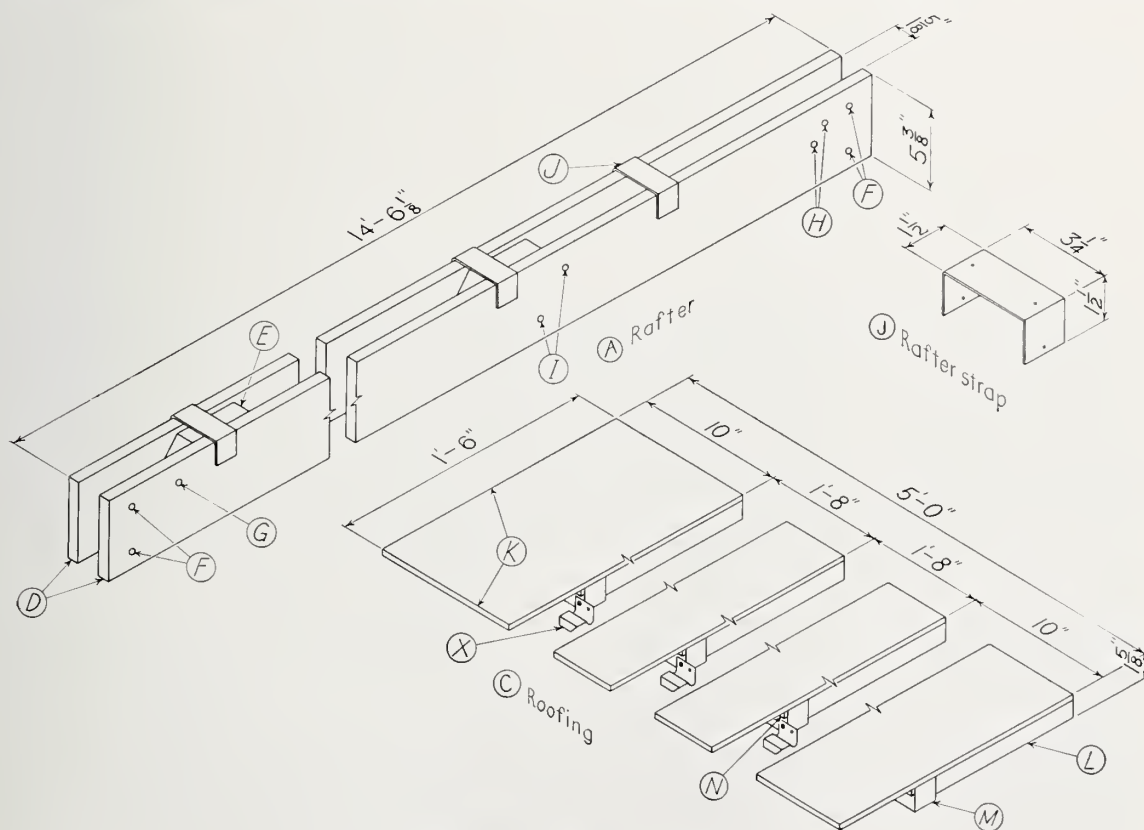
FIGURE 32.—Details of roof DN.

There were 13 sheet-steel rafter straps, *J*, No. 16 U. S. Standard Gage (0.0613 in), across the upper edge of each rafter, spaced 1 ft 0 $\frac{7}{16}$ in. on centers, the upper strap being 1 ft 3 $\frac{7}{8}$ in. from

A, rafter; *D*, boards; *E*, blocks; *F*, *G*, *H*, *I*, holes; *J*, rafter strap; *C*, roofing; *K*, outside face; *L*, inside face; *M*, clip rail; *N*, rubber strip; *X*, siding clip.

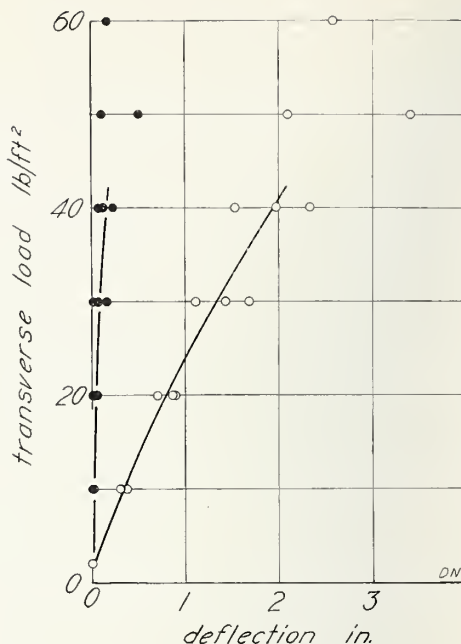
FIGURE 33.—*Transverse load on roof DN.*

Load-deflection (open circles) and load-set (solid circles) results for specimens *DN-T1*, *T2*, and *T3* on the span 12 ft 0 in.

In specimen *T1*, under a load of 31.7 lb/ft² the middle rafter cracked at a knot under a loading roller. Under a load of 38.0 lb/ft², one outer rafter cracked at a knot near midspan and ruptured under a load of 60.7 lb/ft². Under the maximum load, all the rafters ruptured.

In specimen *T2*, one outer rafter cracked at a knot near midspan under a load of 24.3 lb/ft² and ruptured under a load of 45.0 lb/ft². The middle rafter ruptured at midspan under a load of 48.6 lb/ft².

Under a load of 40.0 lb/ft² on specimen *T3*, one board in an outer rafter cracked at a knot near midspan and the other board ruptured at knots under the loading rollers. Under the maximum load, the middle rafter ruptured under both loading rollers.

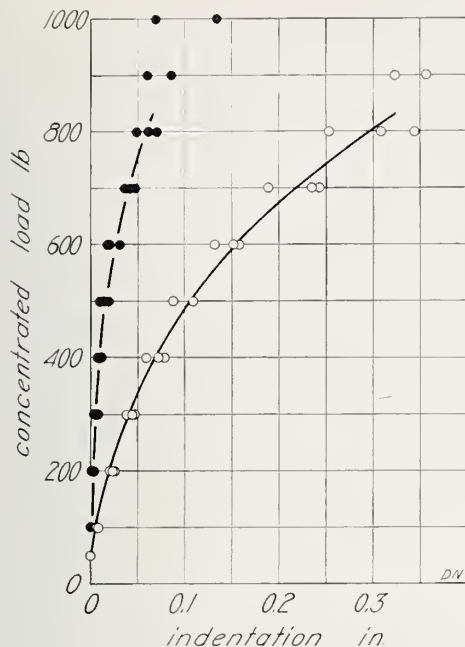
FIGURE 34.—Concentrated load on roof DN.

Load-indentation (open circles) and load-set (solid circles) results for specimens DN-P1, P2, and P3.

The concentrated loads were applied to the roofing midway between two rafters and 10 in. from the exposed edge of the plywood. Under the maximum load on specimen *P2*, the disk punched through the plywood roofing. Under

the maximum load on specimens P1 and P3, the plywood cracked along the grain near the disk.

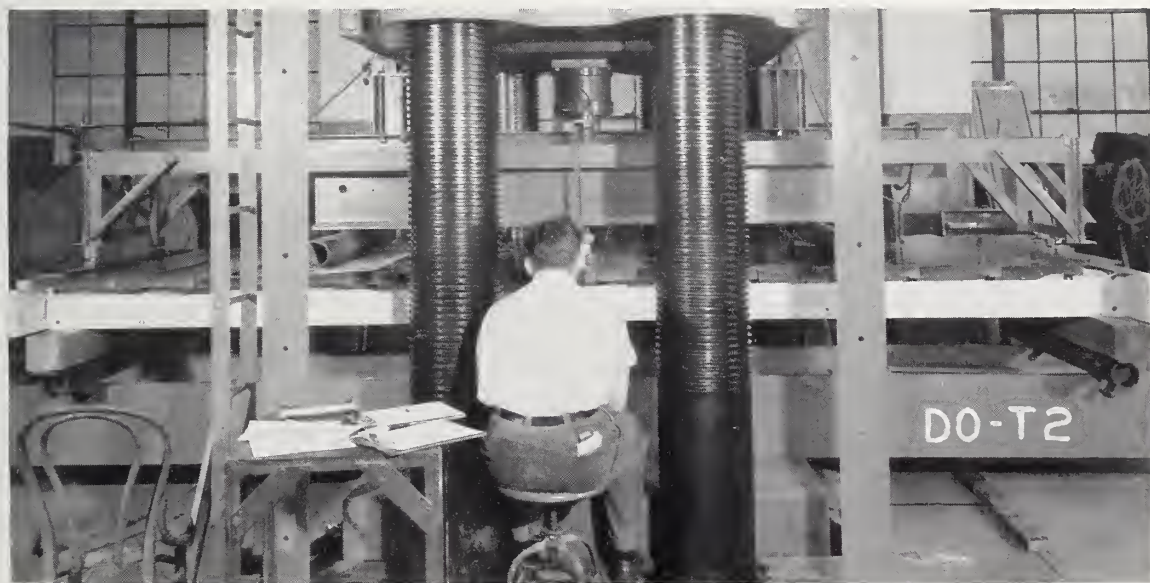
FIGURE 35.—Roof specimen DO-T2 during the transverse test.

Roof specimen DO-T2 under transverse load is shown in figure 35. The results for speci-

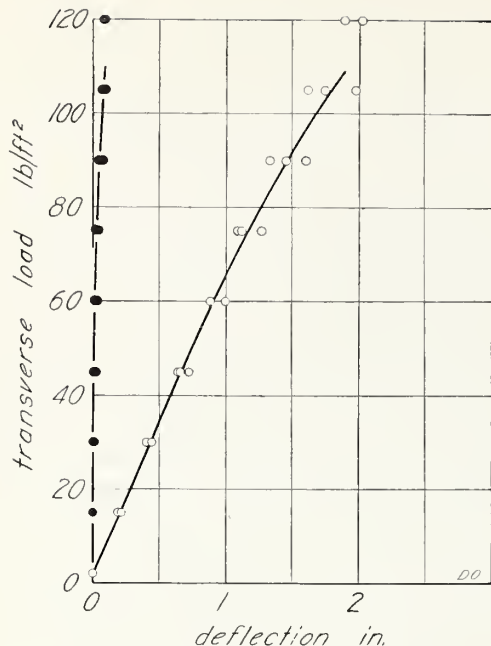
FIGURE 36.—Transverse load on roof DO.

Load-deflection (open circles) and load-set (solid circles) results for specimens DO-T1, T2, and T3.

One outer rafter in specimen T1 cracked at a knot near midspan under a load of 71.4 lb/ft². Under a load of 120 lb/ft², the other outer rafter cracked at a knot near a loading roller. The middle rafter cracked under a load of 141 lb/ft². Under the maximum load, one outer rafter ruptured.

In specimen T2 under a load of 67.1 lb/ft², cracks appeared at a knot near midspan in an outer rafter. Under a load of 117 lb/ft², a crack occurred at midspan in the middle rafter. Under the maximum load, all the rafters ruptured.

In specimen T3 under a load of 68.0 lb/ft², a crack appeared at a knot in both the middle and one outer rafter. The other outer rafter cracked near midspan under a load of 103 lb/ft². Under the maximum load, each rafter ruptured.

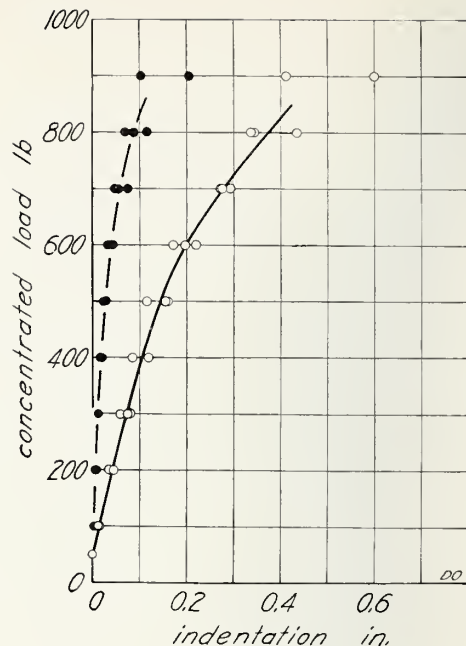
FIGURE 37.—Concentrated load on roof DO.

Load-indentation (open circles) and load-set (solid circles) results for specimens DO-P1, P2, and P3.

The results of the concentrated loads on roof specimens DO-P1, P2, and P3 are shown in table 12 and in figure 37.

The concentrated loads were applied to the roofing midway between two rafters and 10 in. from the exposed edge of the plywood. Under a load of 750 lb on specimen P2, the plywood cracked along the grain adjacent to the disk. Under the maximum load on each specimen, the disk punched through the plywood.

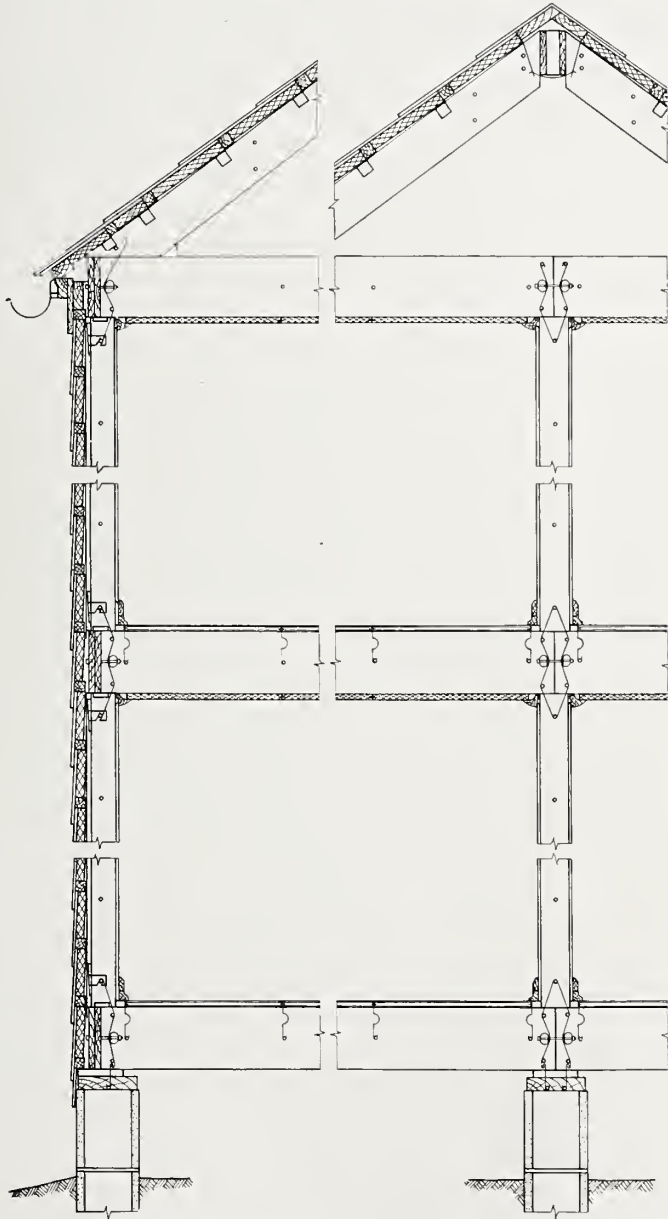
FIGURE 38.—*Typical details of a two-story house assembly*

Tenons of studs in partitions and outside outside walls parallel to joists are seated in

mortises in the joists and are fastened by steel pins through the joist and tenon.
